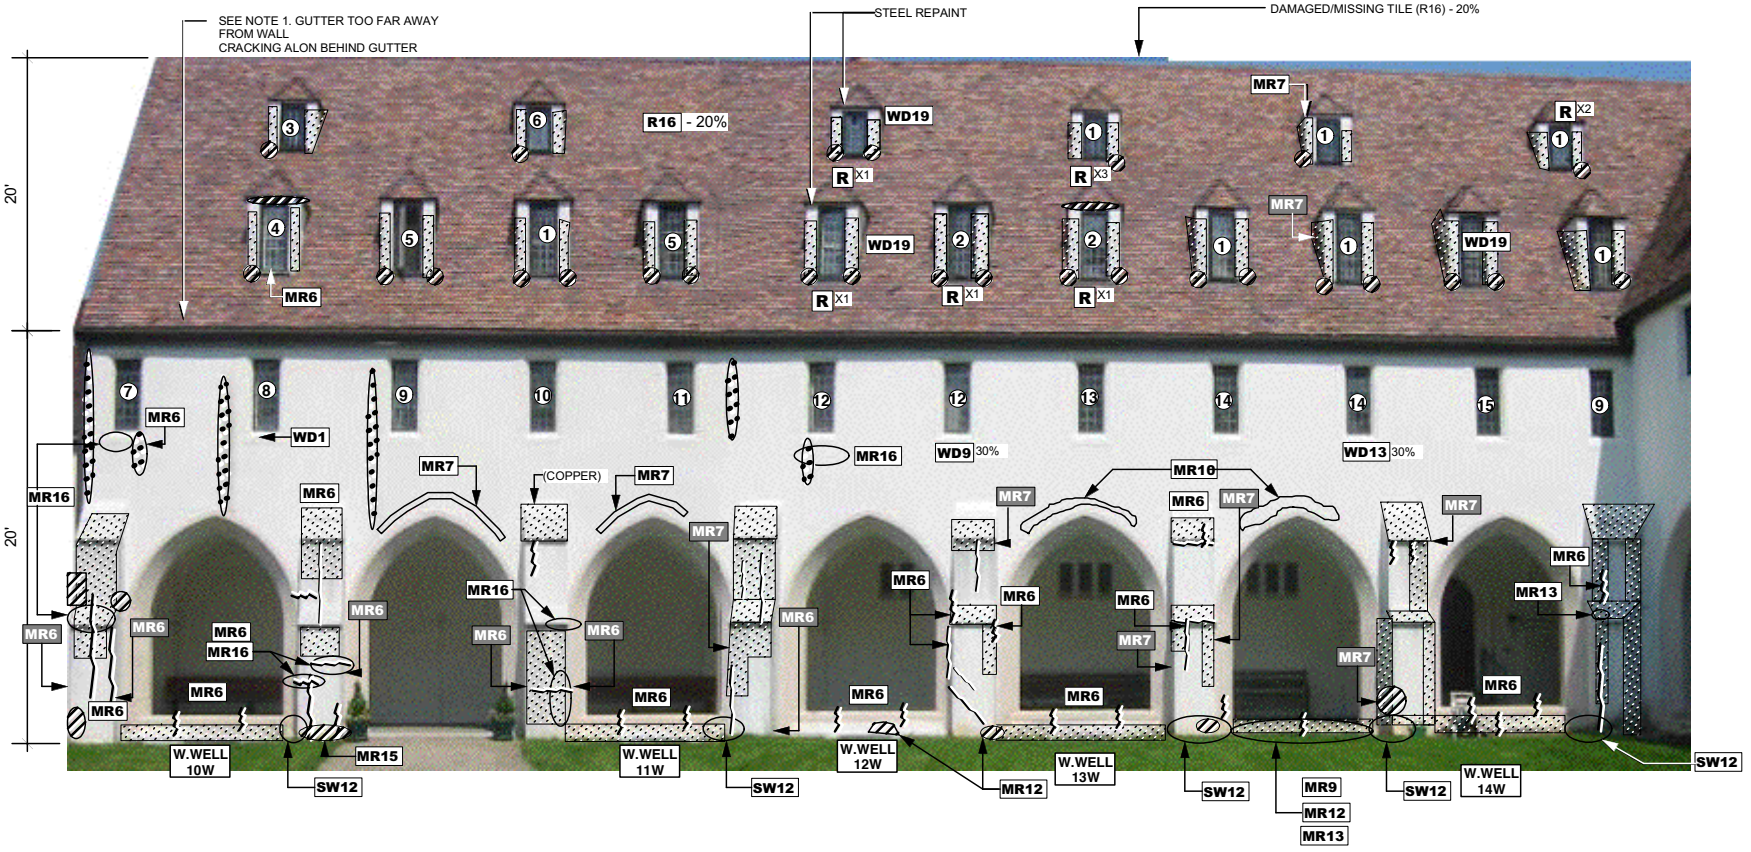
SEE NOTE 1. GUTTER TOO FAR AWAY
FROM WALL
CRACKING ALON BEHIND GUTTER
STEEL REPAINT
DAMAGED/MISSING TILE (R16) - 20%
20'
20'
R16 - 20%
WD19
R X1
R X3
R X2
MR7
MR6
WD1
MR16
WD9 30%
WD13 30%
MR10
(COPPER)
MR13
MR15
W.WELL 10W
W.WELL 11W
W.WELL 12W
W.WELL 13W
W.WELL 14W
SW12
MR12
MR9
MR13
