CONSTRUCTION/WORKING DRAWINGS  
 DEMONSTRATION, N.J.

Phase 3 Restoration  
 Craftsman Farms  
 2352 Rt. 10-W, Box 5  
 Morris Plains, New Jersey

Preliminary Scope of Work  
 South Elevation

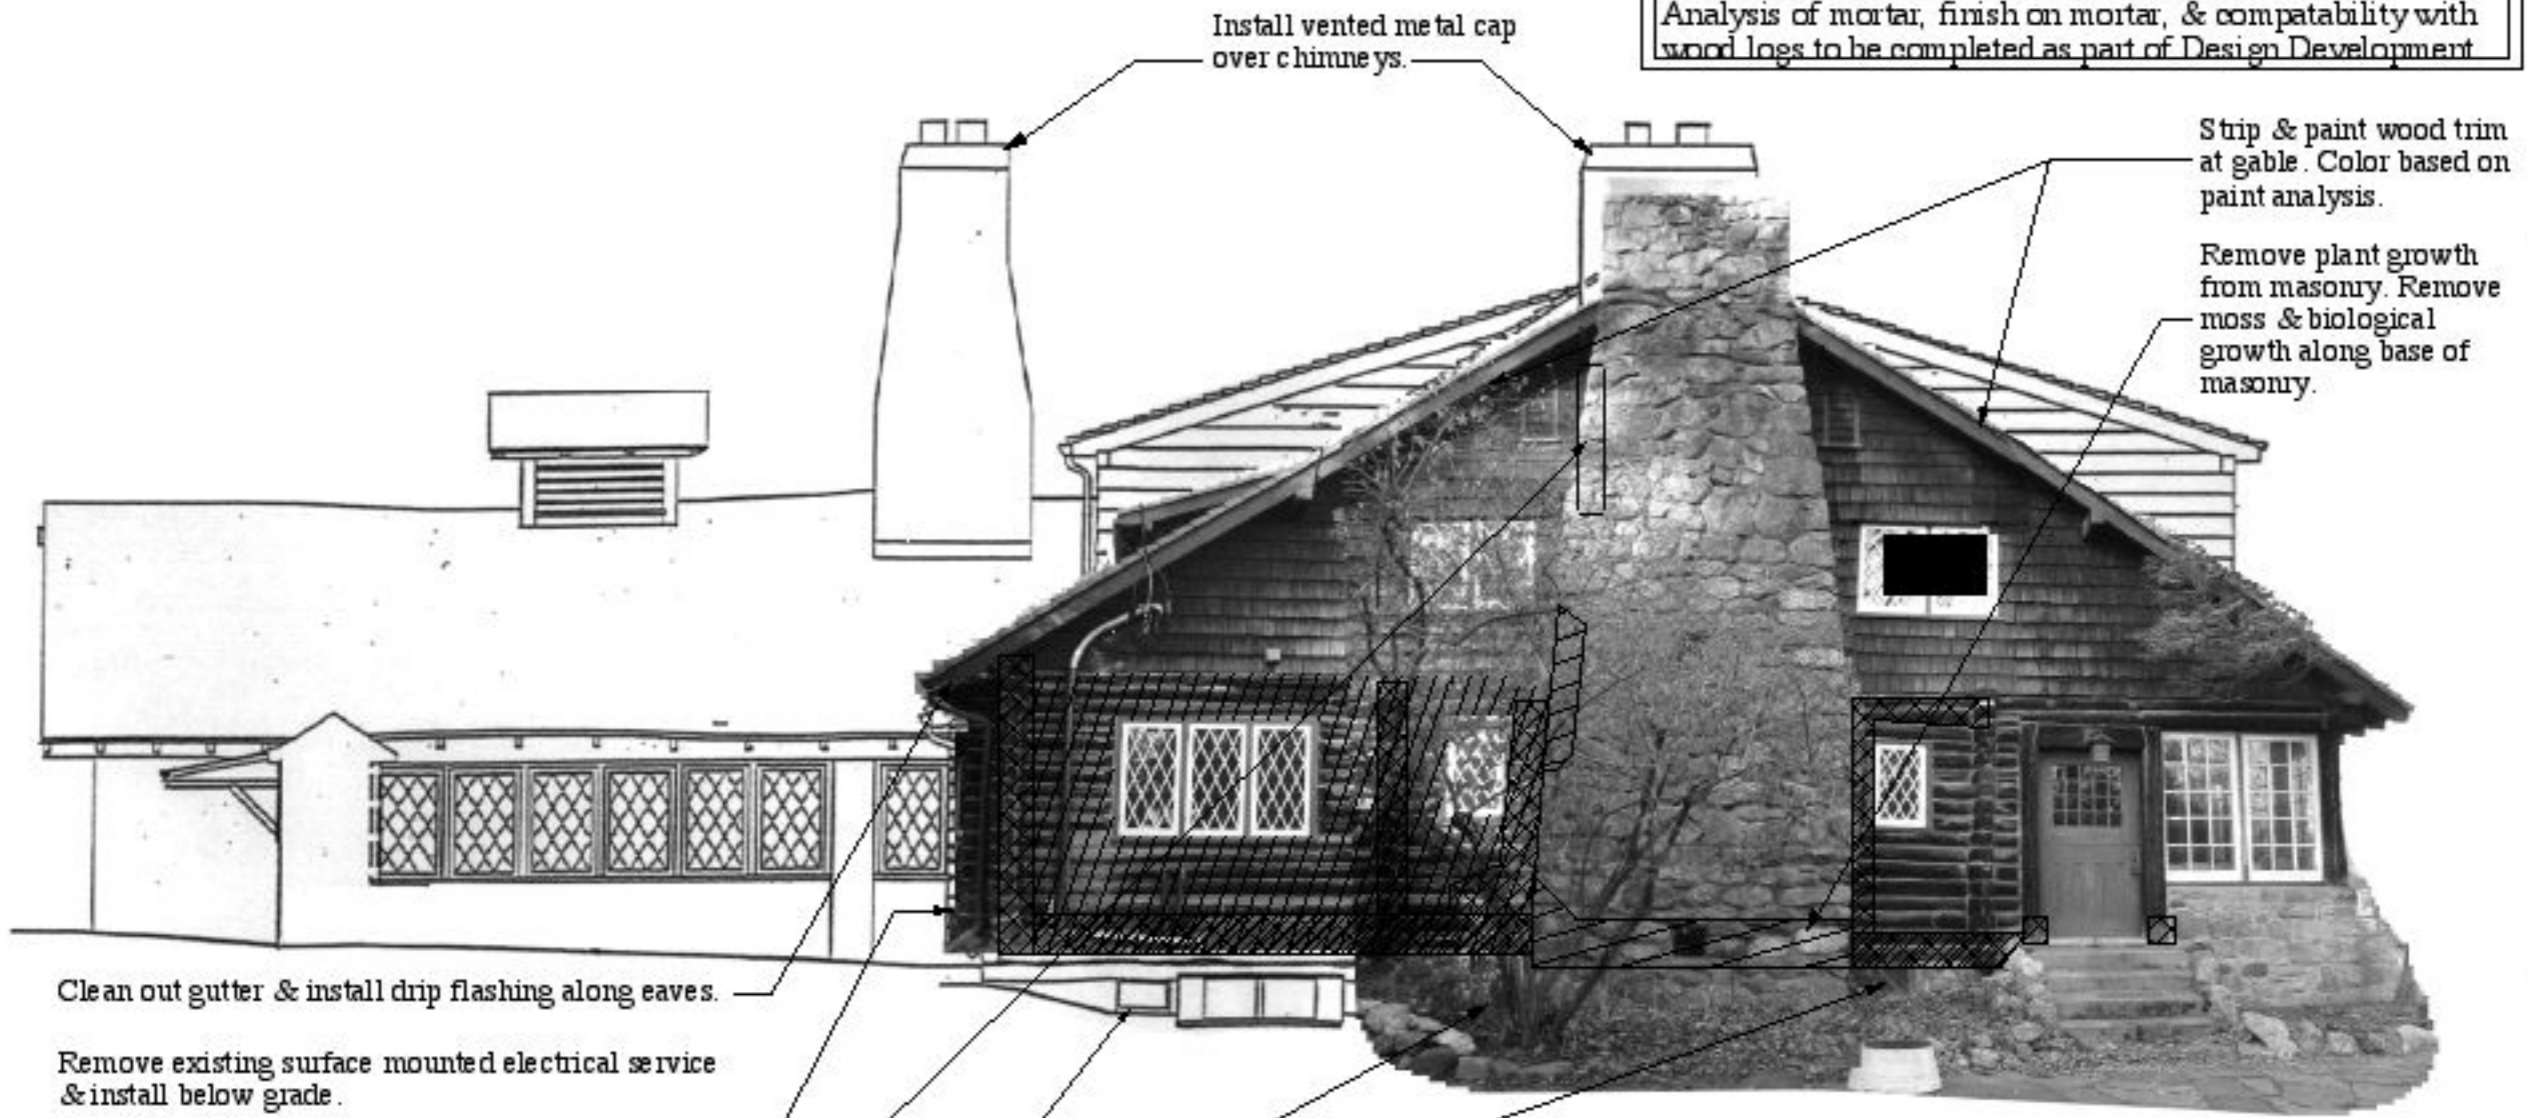
- Clean out gutter & install drip flashing along eaves.
- Remove existing surface mounted electrical service & install below grade.
- Remove cement parking at side elevation & replace bottom 2 logs. Install new soft mortar for chinking.
- Replace failed shingles adjacent to chimney.
- Restore basement windows.

Complete mortar analysis & replace all chinking. Remove contemporary hard cementitious mortars.
-

Assume logs to be severely deteriorated & require replacement. Extensive testing & wood analysis to be completed during Design Development.
-

Minor wood rot. Consolidation required. To be assessed during Design Development.
-

Rake out & re point mortar joints in masonry.
